FULL INSPECTION REPORT

Name: Jose Antonio Lopez
Inspection #: 17-0209L
Inspector: Mark Carreras
Property Address: 13201 Mustang Trail
Southwest Ranches, FL 33330

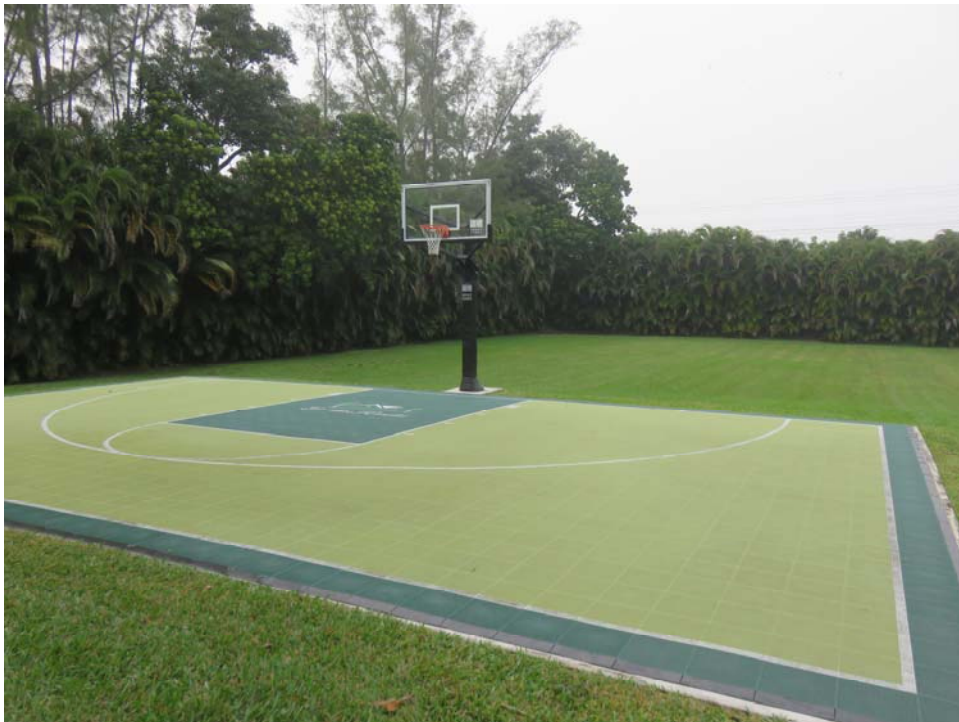
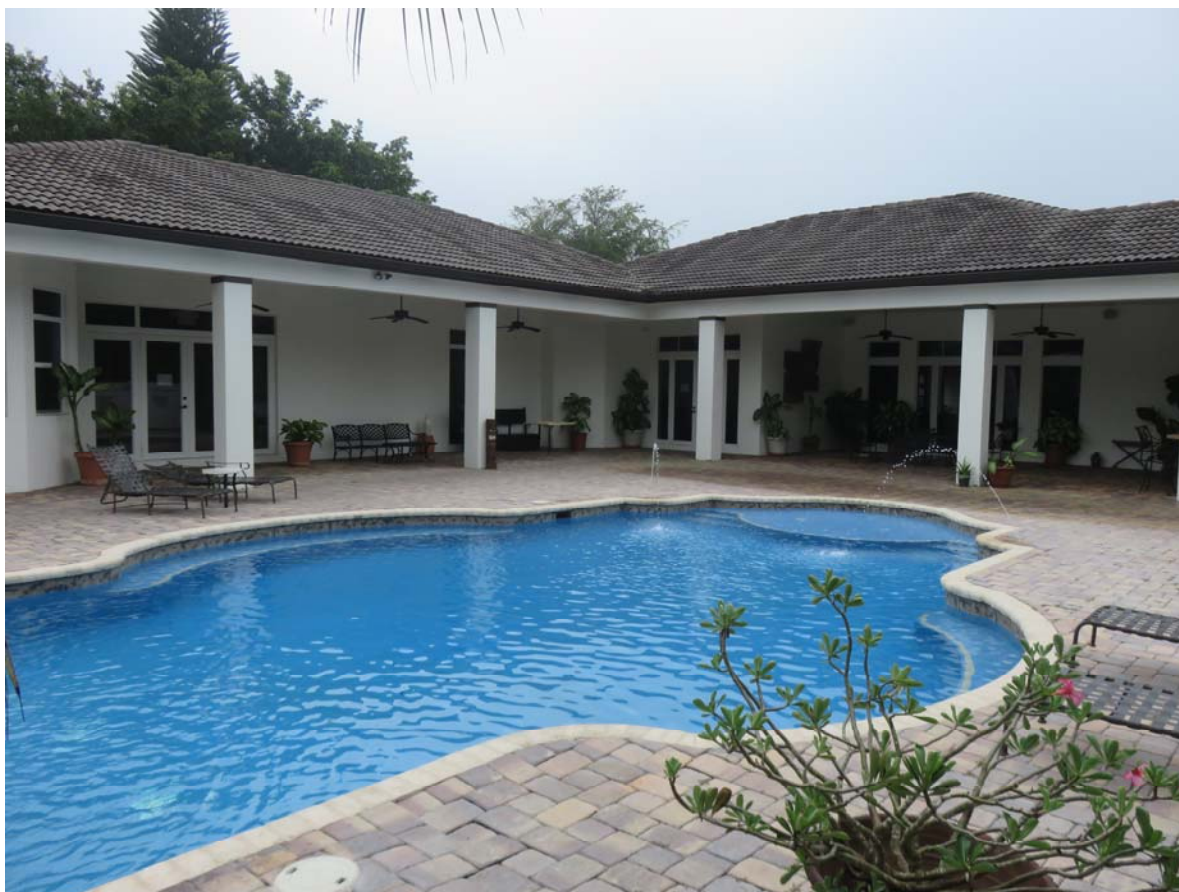
The home was constructed in 2002 and at the time of the inspection the exterior of the home appears to be in good overall condition. No major deficiencies were discovered during the course of our inspection. Please refer to the end of this report for more details.

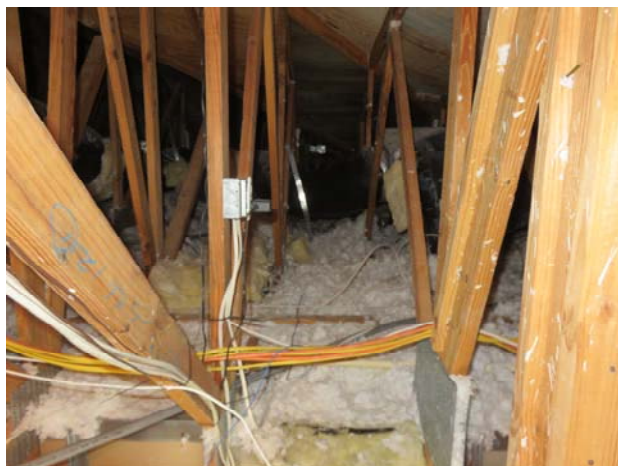
At the time of inspection the residential ceiling insulation measures approximately 19. The minimum required R value is 19. No further actions are necessary.

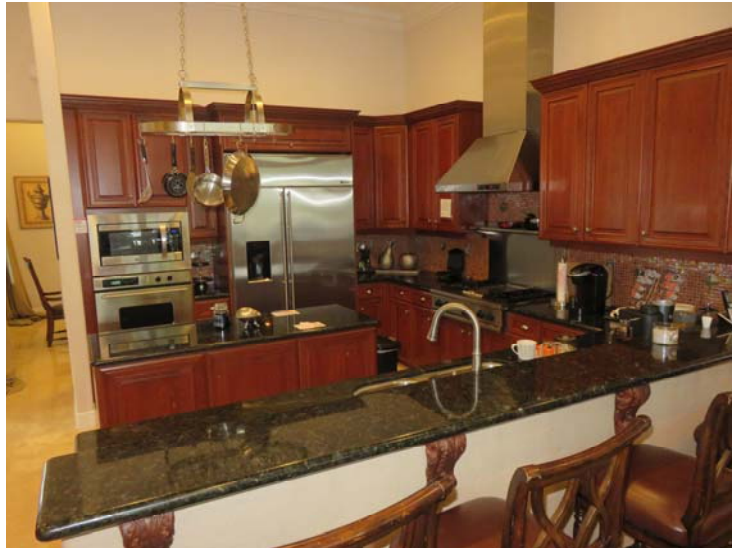
At the time of inspection the interior of the home was in overall good condition for its age. During the course of our inspection some deficiencies were discovered. All of the kitchen appliances are in good overall condition. Please refer to the end of this report for more details.

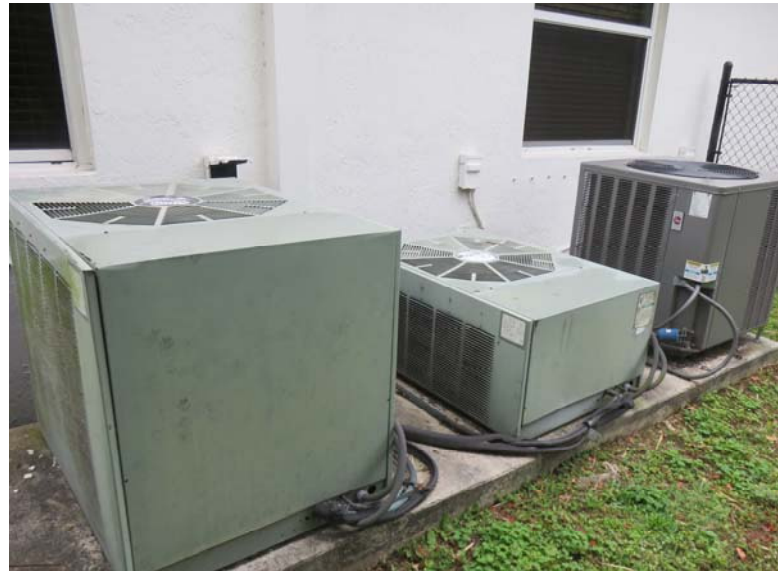
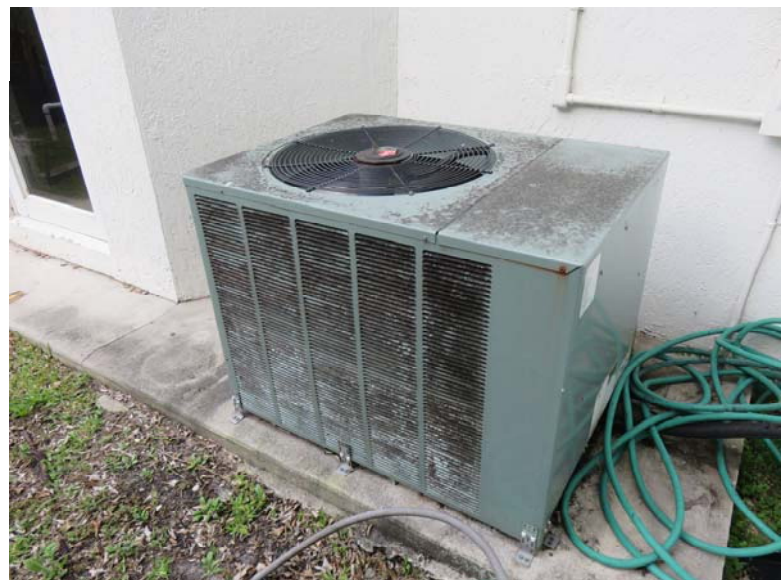
At the time of inspection the split central air conditioning systems were functioning and cooling adequately. No major deficiencies were discovered during the course of our inspection.

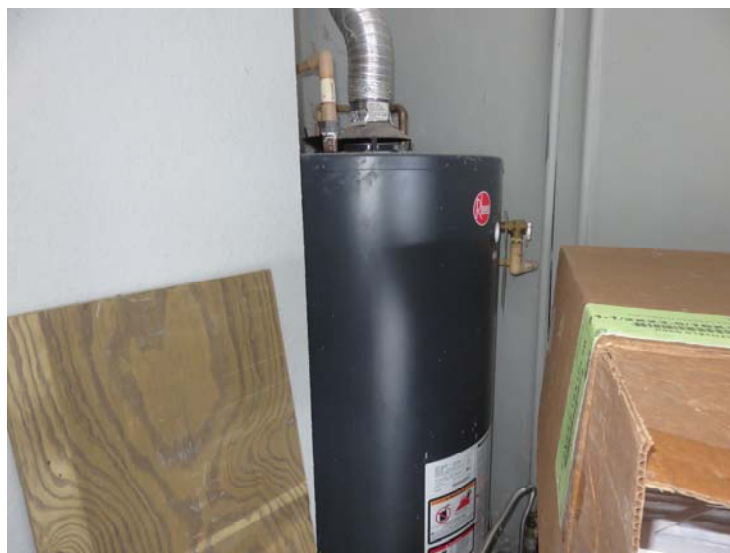
At the time of inspection the plumbing system appears to be functioning and in good condition. Functional flow and adequate drainage was observed during the course of our inspection. No further actions are necessary.

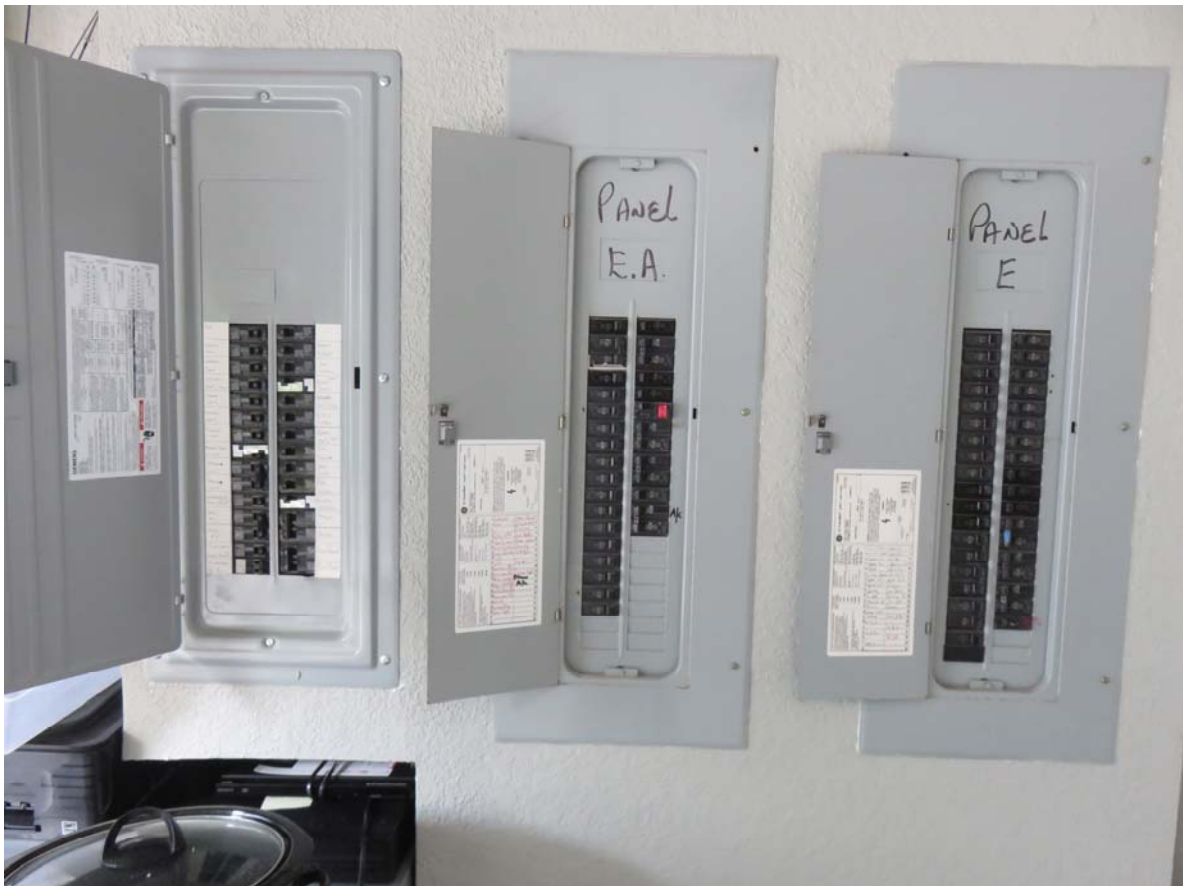
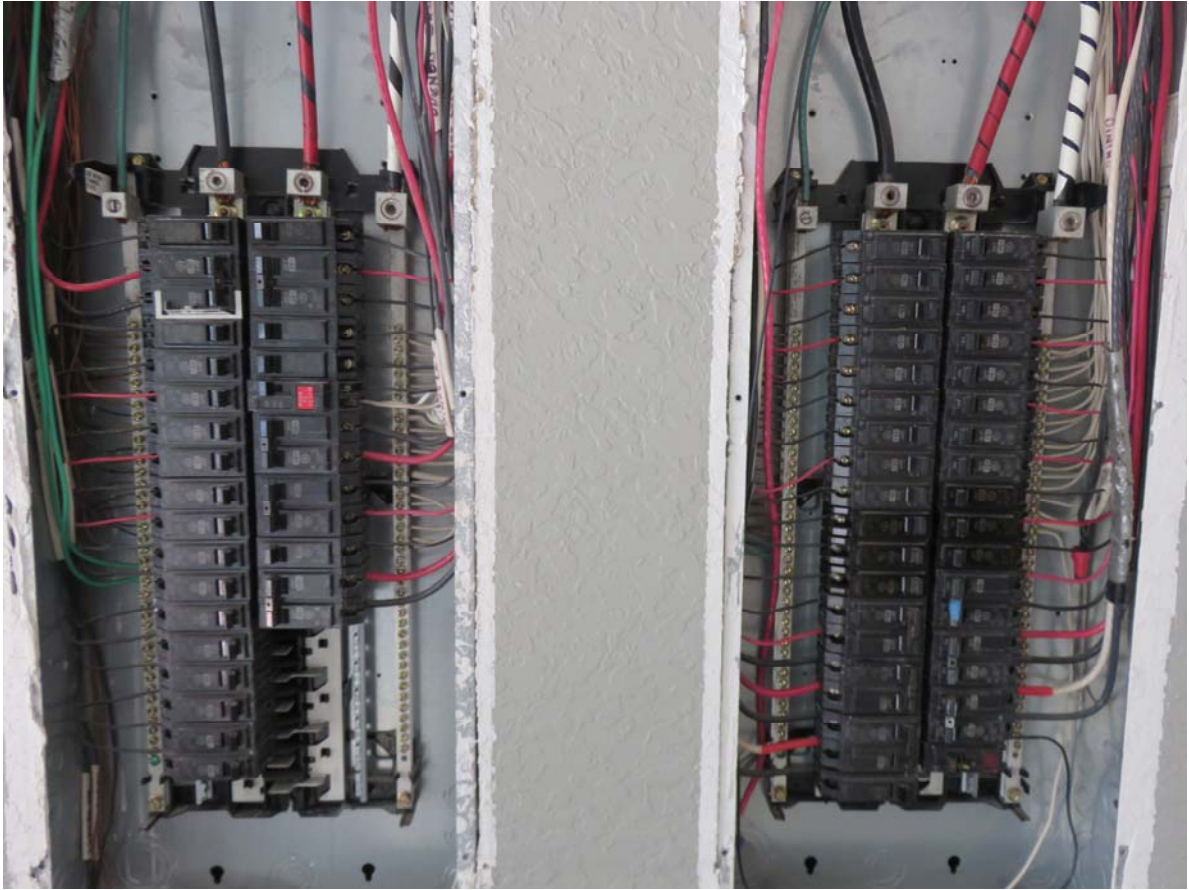
At the time of inspection the electrical system appears to be sufficient in size and functioning correctly.

We recommend you install GFCI receptacles wherever necessary. GFCI receptacles are a safety device that senses any shock hazard and interrupts the flow of electricity in the circuit. *(if applicable)

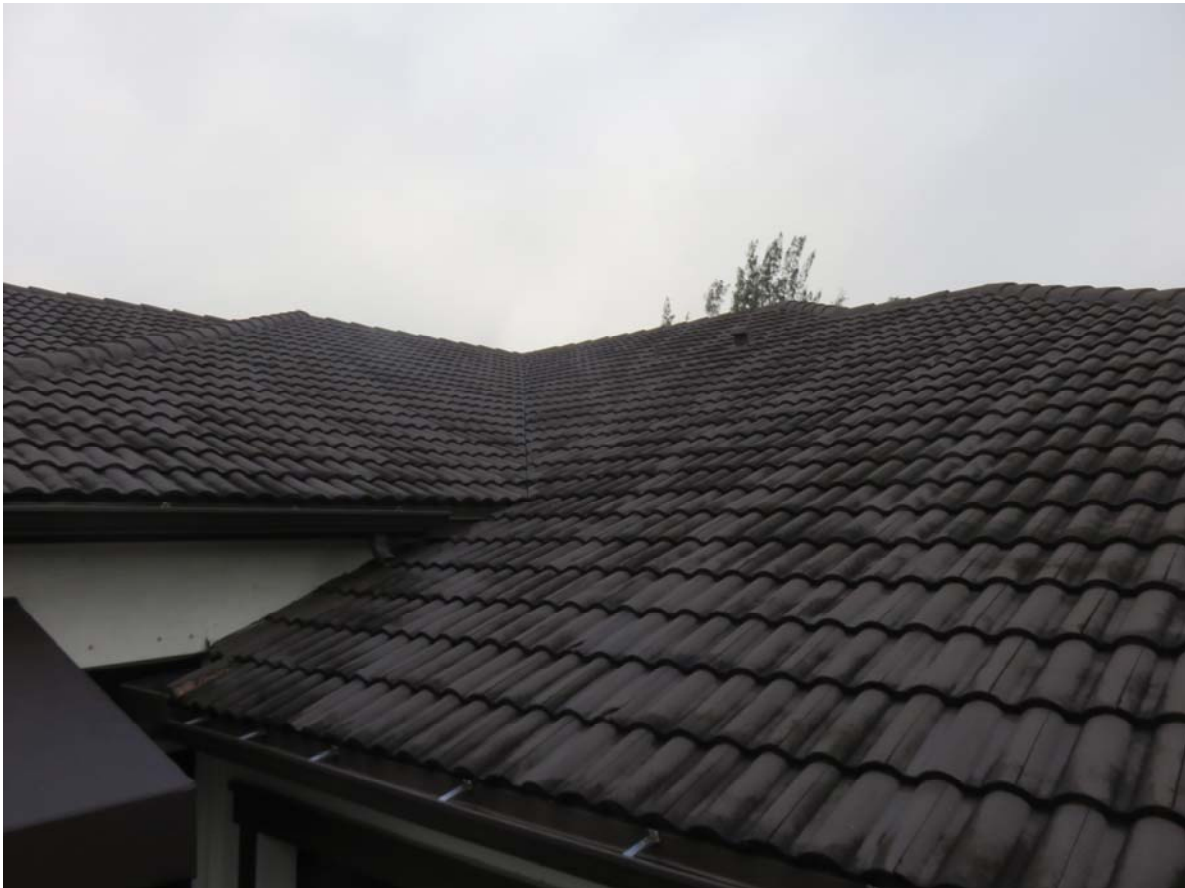
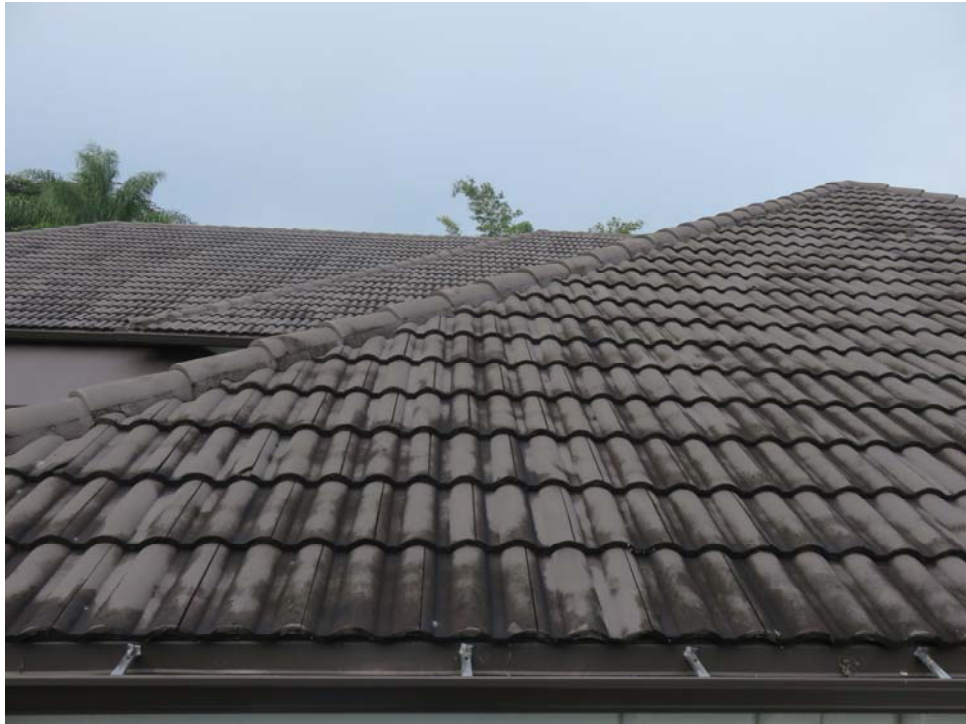
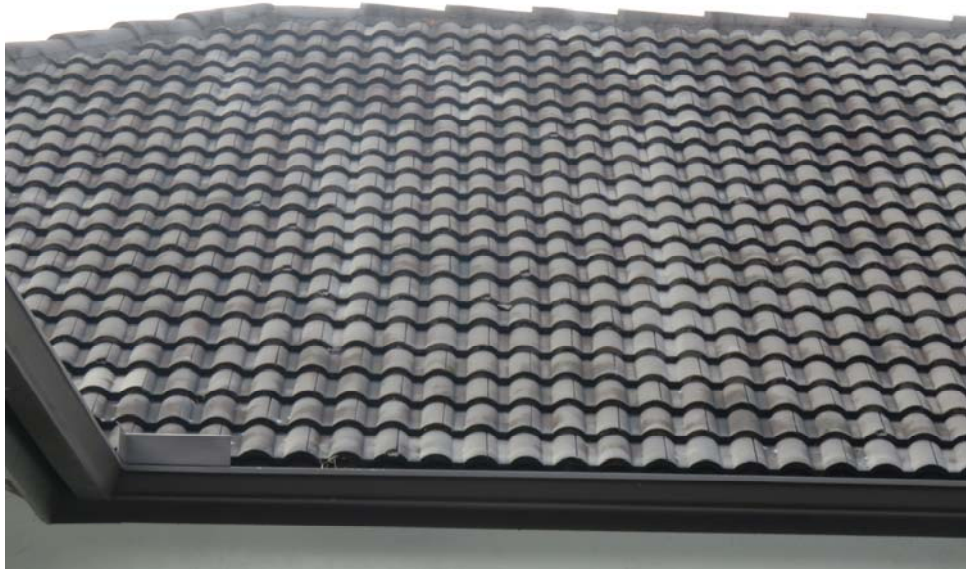
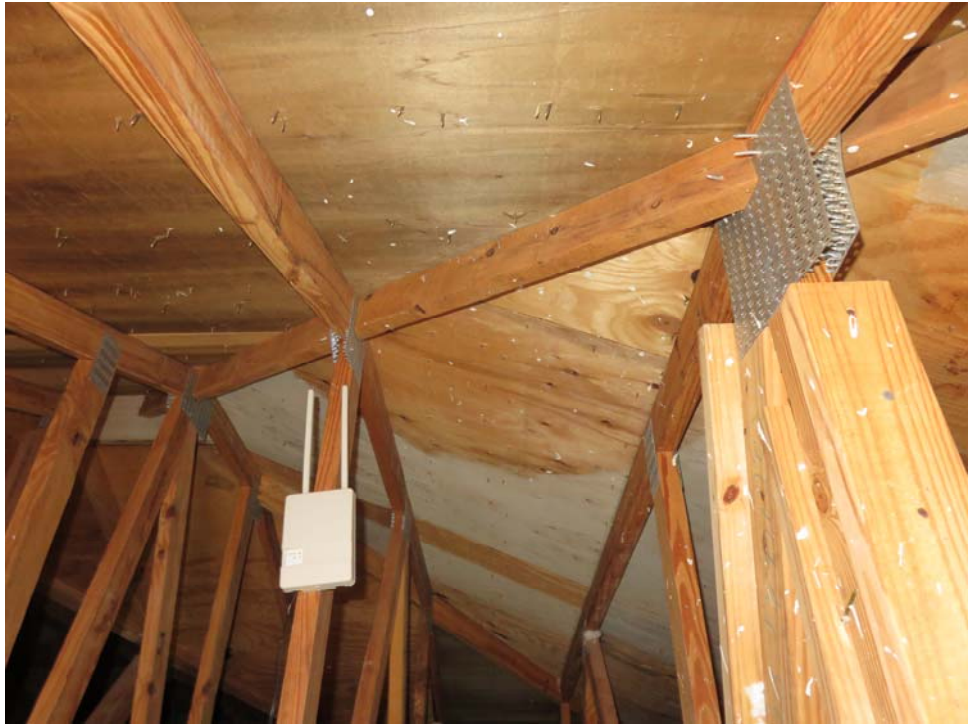
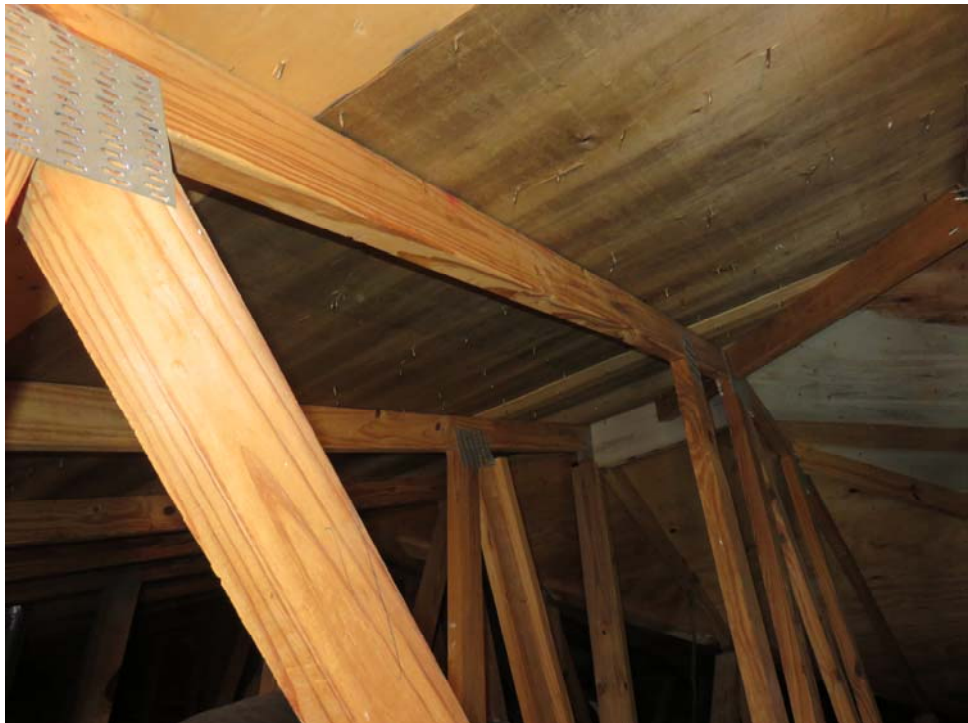
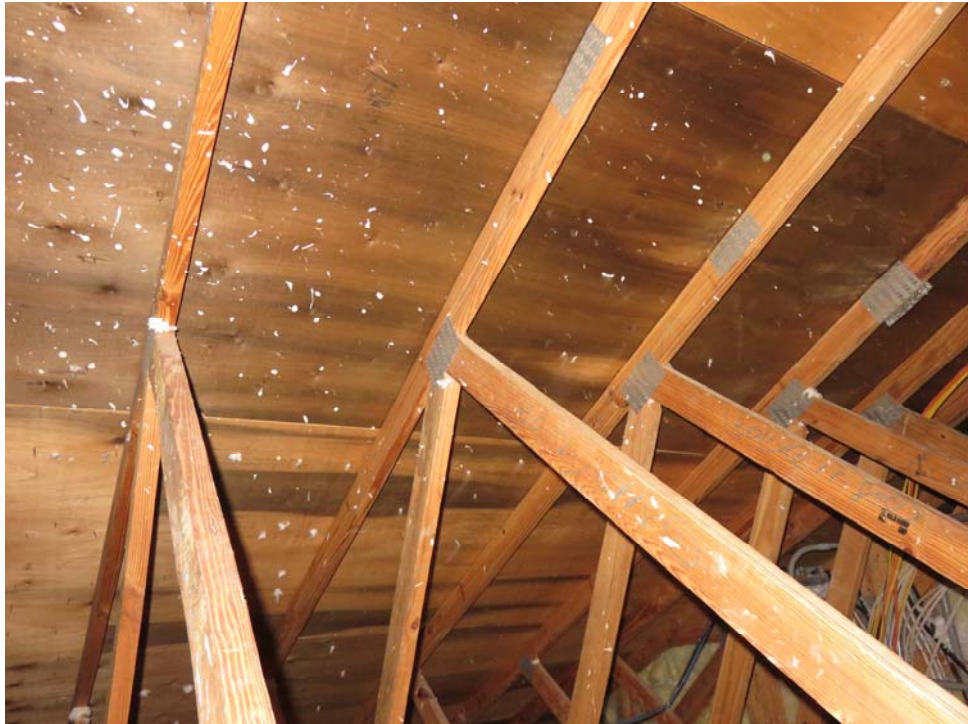
The tile roof covering is 15+ years old and is in good condition. The roof covering was inspected from the roof's eave and the attic area as previously disclosed. Below are photographs of the roof's current condition. No major deficiencies were discovered during the course of our inspection. Sections of the "white" gutters on the front home's exposure are in need of replacing.

Estimated Repair Cost: \$ 1,000.00 (Gutters)

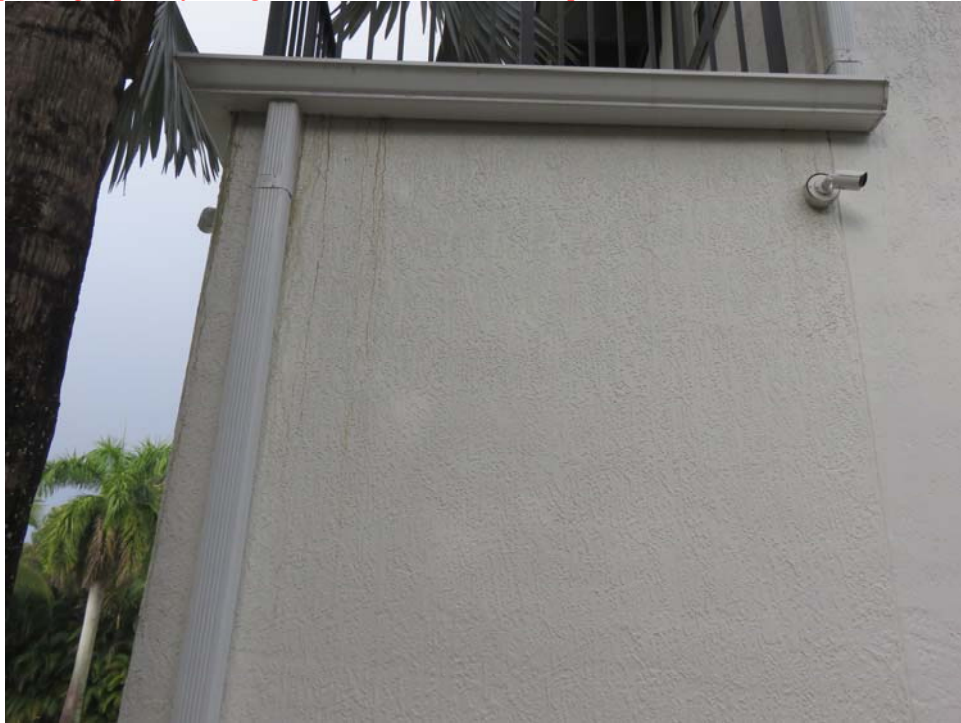
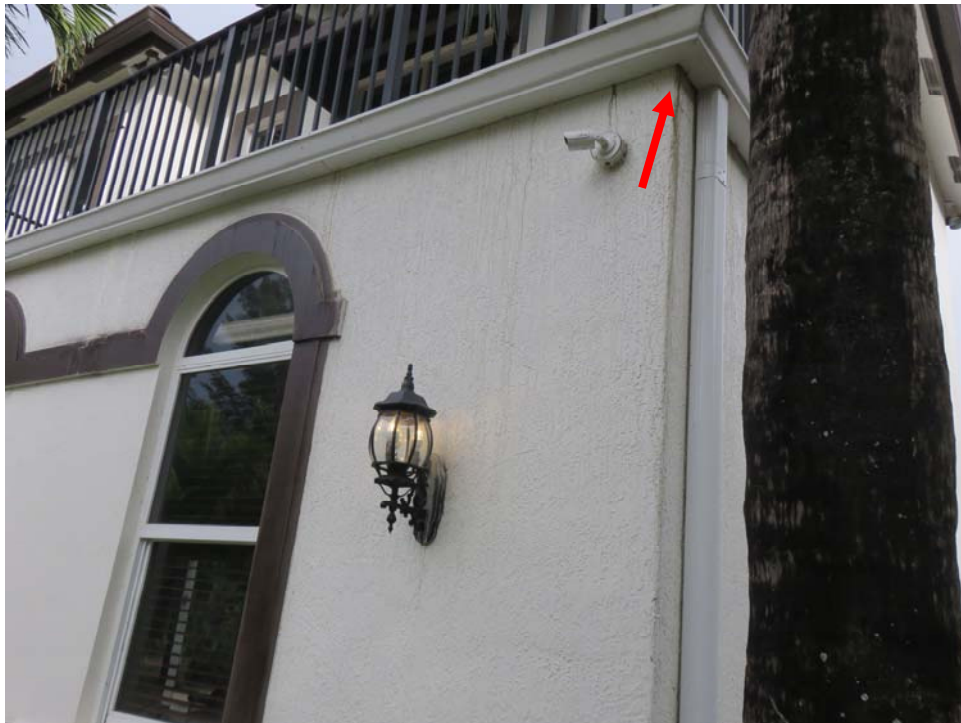
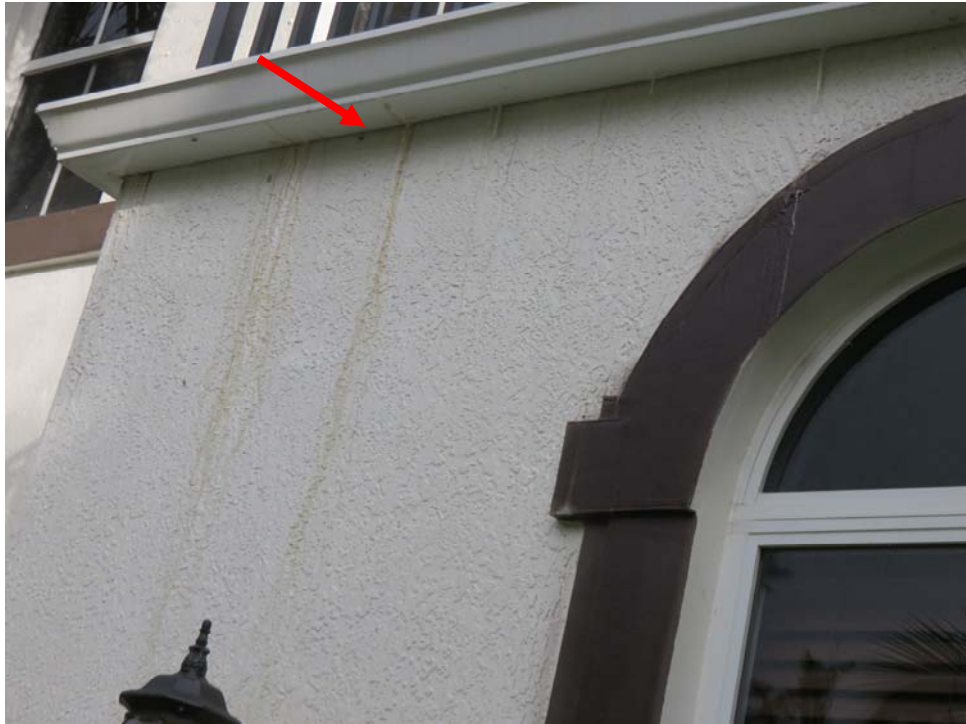
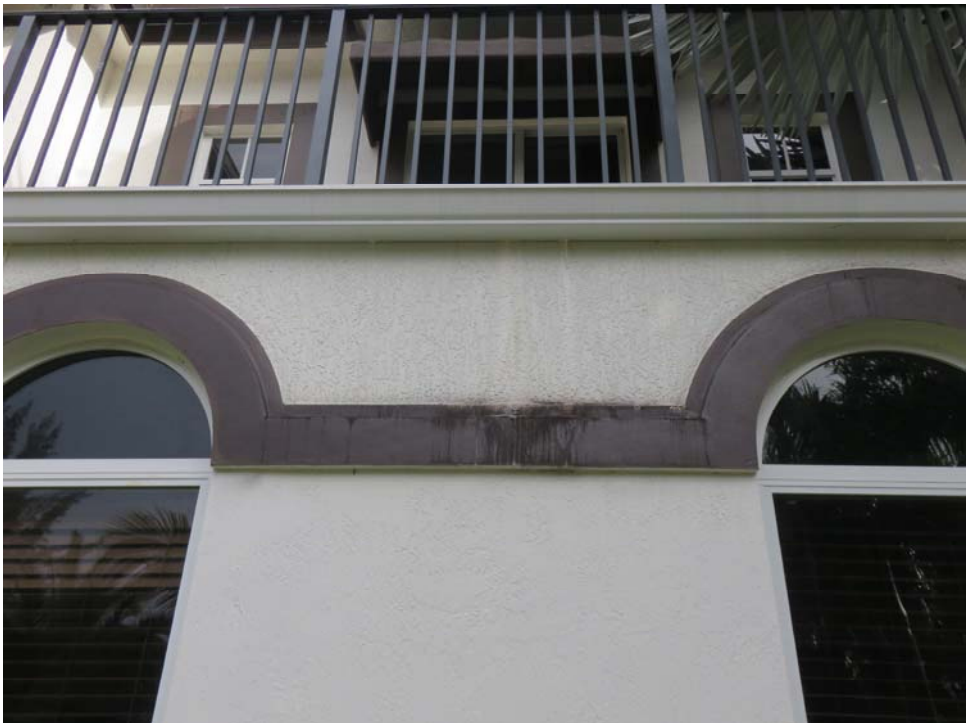
As previously stated in the "Roofing Section" of this report. Below are photographs of the gutters that need to be replaced.
